Manhole Inspection Summary

Manhole # S53K__055MH

Insp Date: **2/10/09 11:43 AM**

Location Address: **801 FAIT-ALLEY-HUDSON**

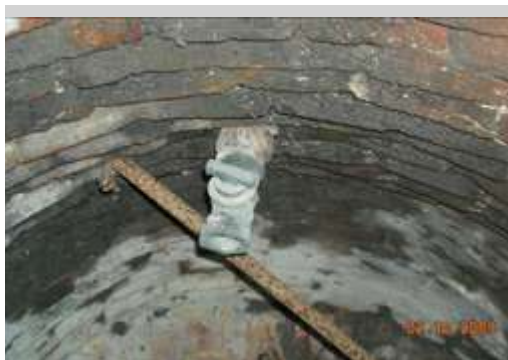
MISC.

PIPE INTRUSION THROUGH CORBEL
@ 6 OCLOCK

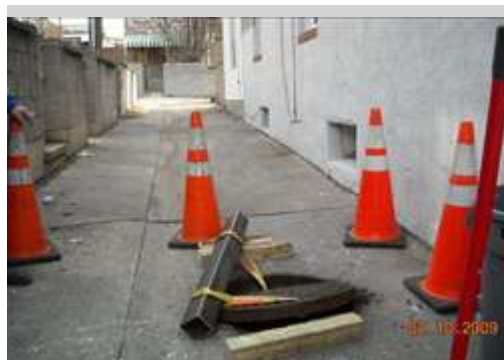
MISC.

Comments **USED HYDROLIC CAR JACK TO OPEN**

PROOF OF MECHANICAL OPENNING

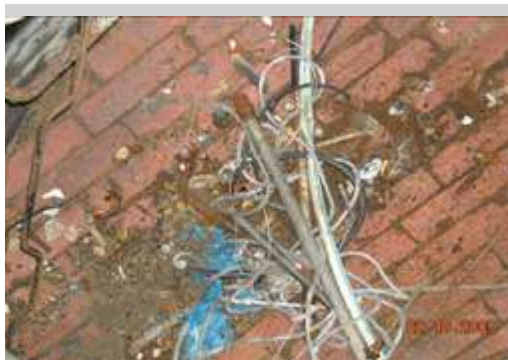
Defect 2

Condition: ☐ Sound ☐ Cracked ☐ Root Intrusion ☐ Deteriorated ☐ Leaks ☒ **Debris**

Steps Count: **3** Missing: **0** ☒ **Corroded**

DEBRIS IN TERMINAL CHANNEL,
corroded steps

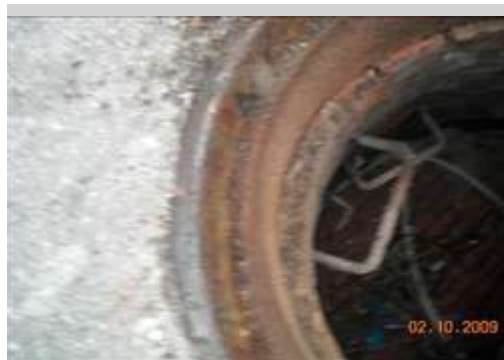
Defect 1

Frame Offset: **2** (in.) Condition: ☒ Sound ☐ Cracked ☐ Leaks

FRAME OFFSET

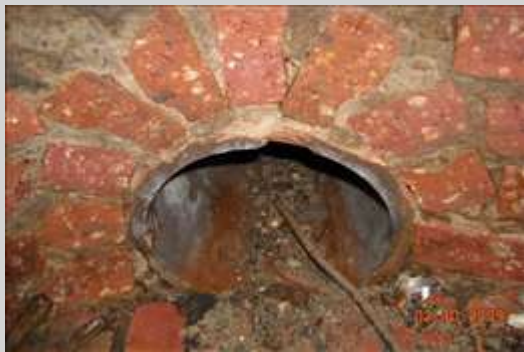
12 O'Clock Outflow

8 in. Circular Gravity Sewer
Pipe Out @ 12 O'Clock

Infiltration: **None** Pipe Seal Cond: **Cracked**
